## FIU PEDESTRIAN BRIDGE FAILURE

PROJECT: Florida International University (FIU) intended to build a concrete pedestrian bridge to cross an 8-lane major arterial highway, SW 8th Street (Route US41), and Tamiami canal connecting the Maidique campus in Miami and the Sweetwater residential community where many students live.

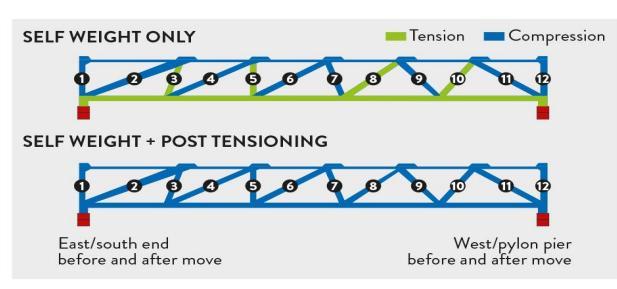
#### **STAGE 1: IN POSITION IN THE YARD**

Supported on its end diaphragms, truss members 2 and 11 are in compression. Post tensioning is correctly applied to put the bottom chord in compression also.

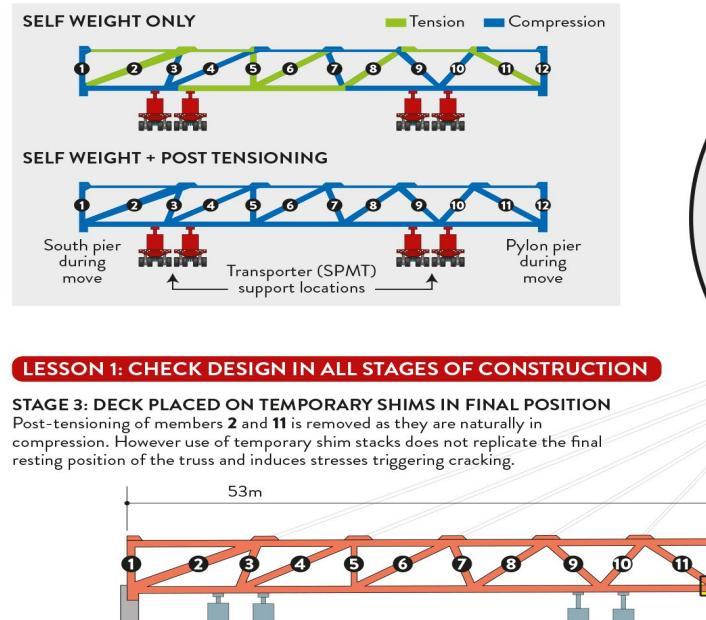
#### **STAGE 2: PREPARING FOR TRANSPORT**

Without post tensioning, members 2 and 11 would now be tension (top image) hence temporary post tensioning is applied (all structure is now in compression).

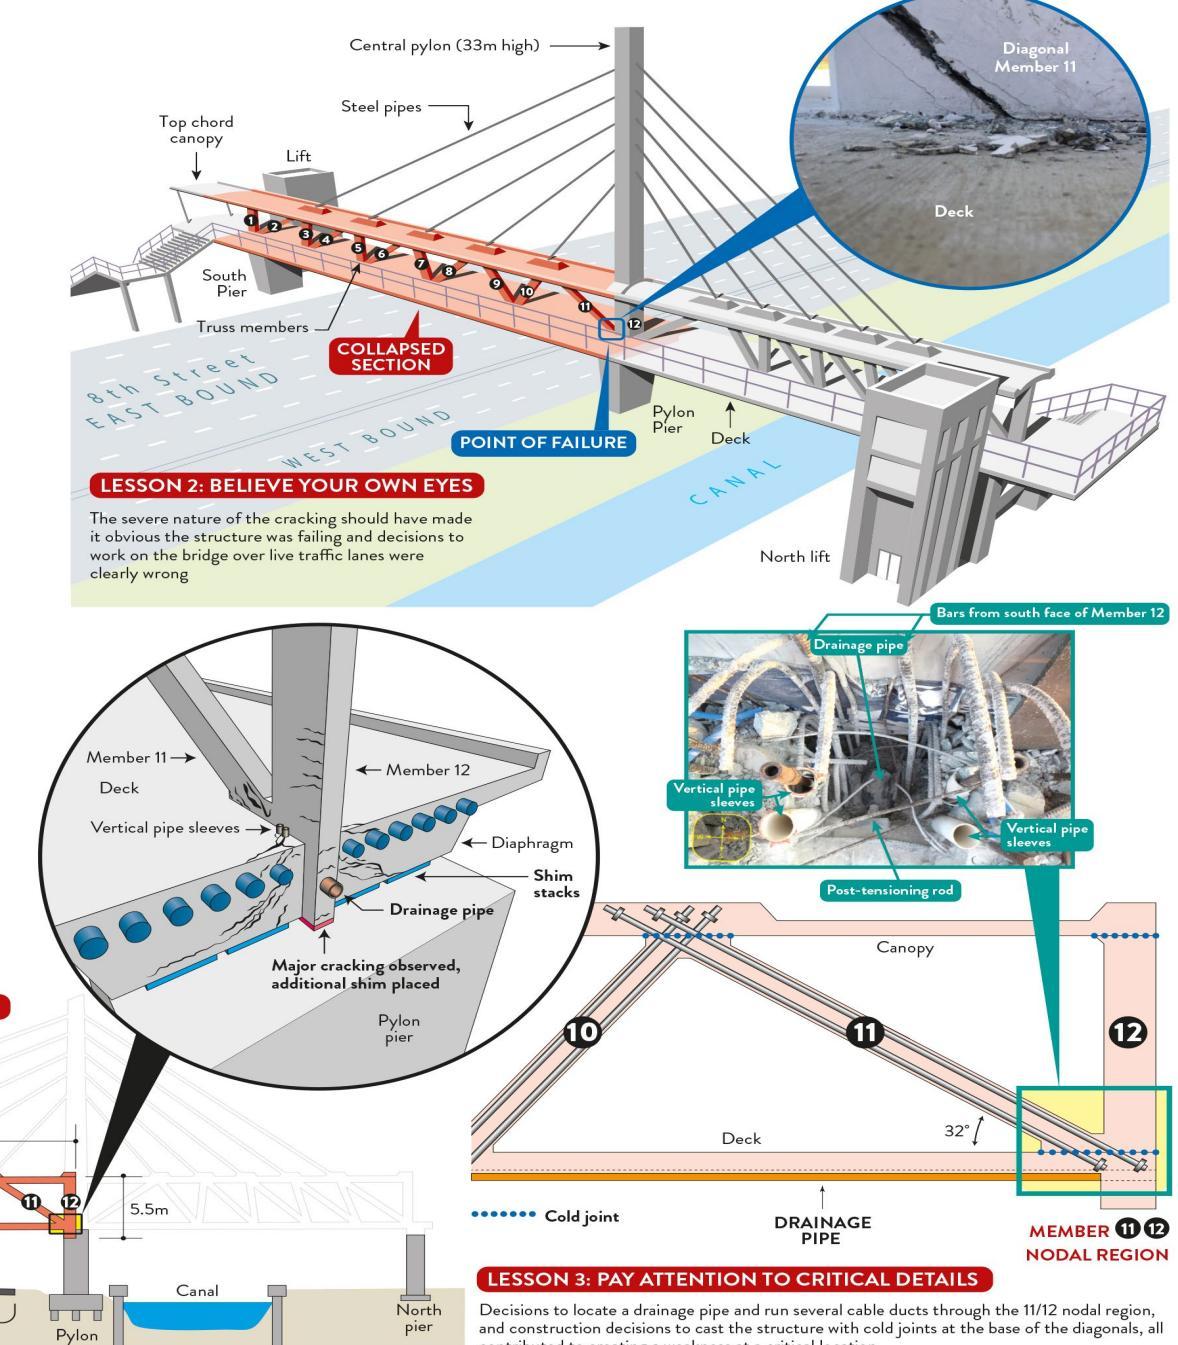
contributed to creating a weakness at a critical location

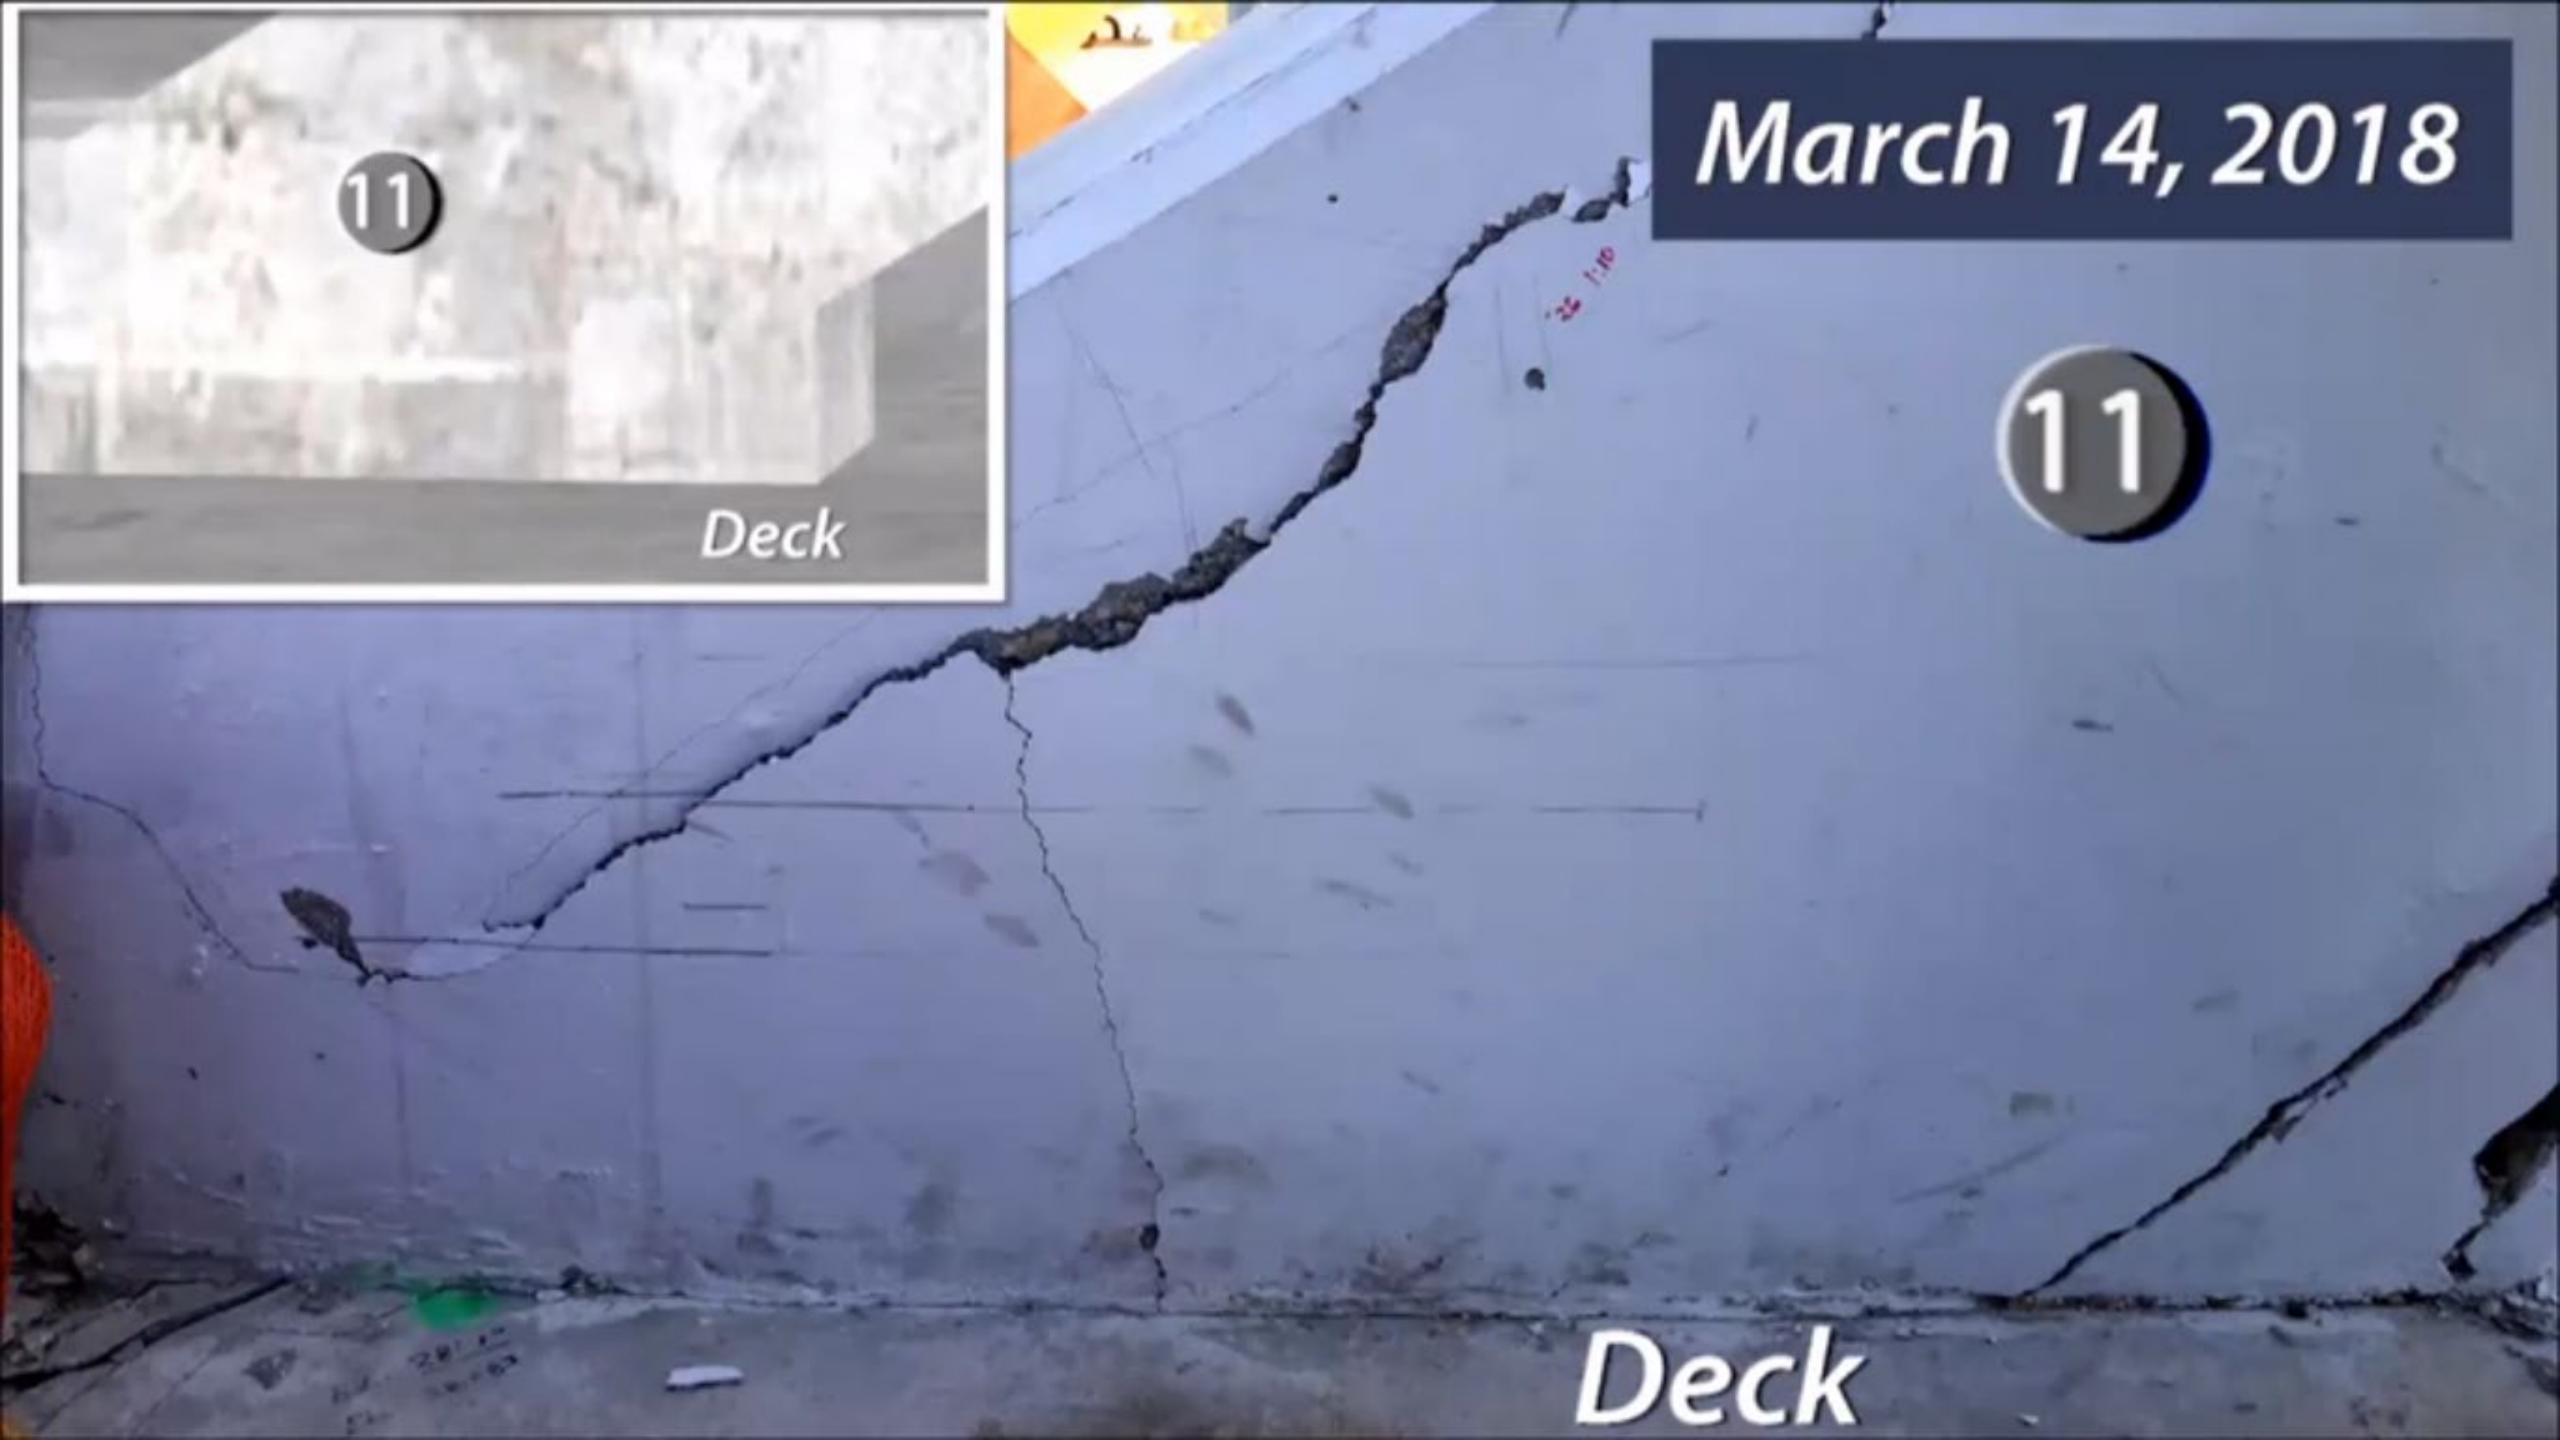
### Diagonal Member 11

- Dynamic cracking is a sign of structural distress:
  - i. Feb 24, cracks appear in Member 11/12 node after form work is removed.

ii. Mar 10, Significant crack growth measured as main span is moved into position and PT rods are de-tensioned.
